CONDITION SURVEYS OF PAVEMENTS SUB-
JECTED TO CHANNELIZED TRAFFIC, REPORT 2,
MARCH AIR FORCE BASE, RIVERSIDE,
CALIFORNIA

CONDITION SURVEYS OF PAVEMENTS
SUBJECTED TO CHANNELIZED TRAFFIC
MARCH AIR FORCE BASE
RIVERSIDE, CALIFORNIA

MISCELLANEOUS PAPER NO. 4-213

Report 2

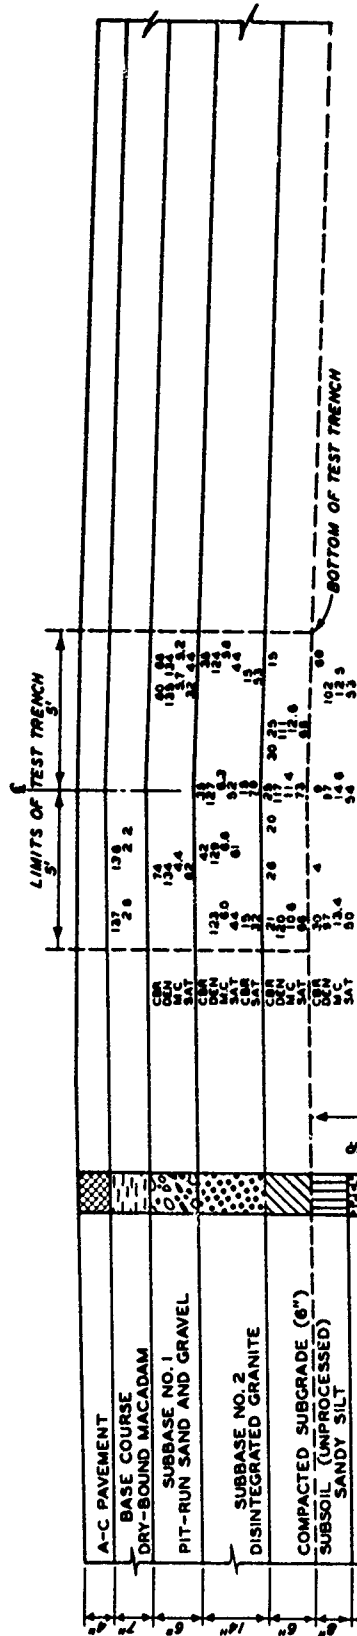
PROFILE OF TEST TRENCH 2
 STA 30+78.5
 NONFAILURE AREA

Testing Agency	Test Hole No.	Location	Reason for Selection
LAD	Trench 2	Taxiway 3, Sta 30+78.5	Area of very slight distress. Trench extends across area where channelized traffic of B-47 planes has occurred.
WES	Pit 1	Taxiway 3, Sta 29+31 on center line	In area of considerable deformation in channelized B-47 traffic lane and 8 ft from trench 1, to supplement data from trench 1.
WES	Pit 2	Taxiway 3, Sta 29+31, 11 ft northwest of center line	Outside of channelized traffic lane and opposite pit 1 for comparison.
WES	Pit 3	Runway 2, 152 ft from southeast end of runway and 4 ft northeast of center line	In lane of B-47 travel on runway where small deformation of pavement has occurred.
WES	Pit 4	Taxiway 3, Sta 12+29 on center line	In channelized B-47 traffic lane where pavement deformation has occurred.

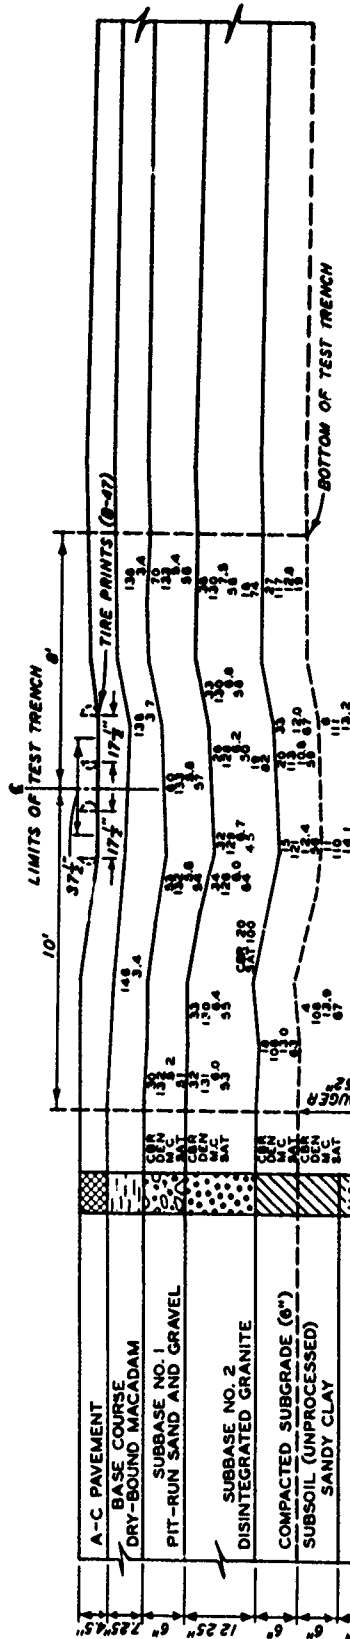
PROFILE OF TEST TRENCH 1
 STA 29+39.5
 THROUGH FAILED AREA

<u>Testing Agency</u>	<u>Test Hole No.</u>	<u>Location</u>	<u>Reason for Selection</u>
LAD	Trench 1	Taxiway 3, Sta 29+39.5	Considerable deformation. Trench extends across area traveled by B-47 planes and into untraveled area.
